## Glacier Lakes and Outburst Floods in the Nepal Himalaya

T. YAMADA<sup>1</sup> & C. K. SHARMA<sup>2</sup>

**Abstract** Severe floods caused by glacier outburst have been frequent in the Nepal Himalayas, occurring more than every three years over the approximately thirty years since the 1960s. Nine potentially dangerous glaciers were identified from flight observations which were carried out in the Eastern and Central Nepal Himalayas on pre- and post-monsoon seasons in 1991. Field surveys were made at the beginning of April, 1992 to Imja Glacier lake located in Khumbu district of Eastern Nepal. This is one of the most dangerous typical glacier lakes that were identified by the flight observations. The field surveys revealed the maximum depth of the lake to be 98.5 m and the total amount of stored water to be 28 million m<sup>3</sup>. Since this lake is dammed up by ice-cored moraine it is concluded as one of the most dangerous glacier lakes in the Himalayas.

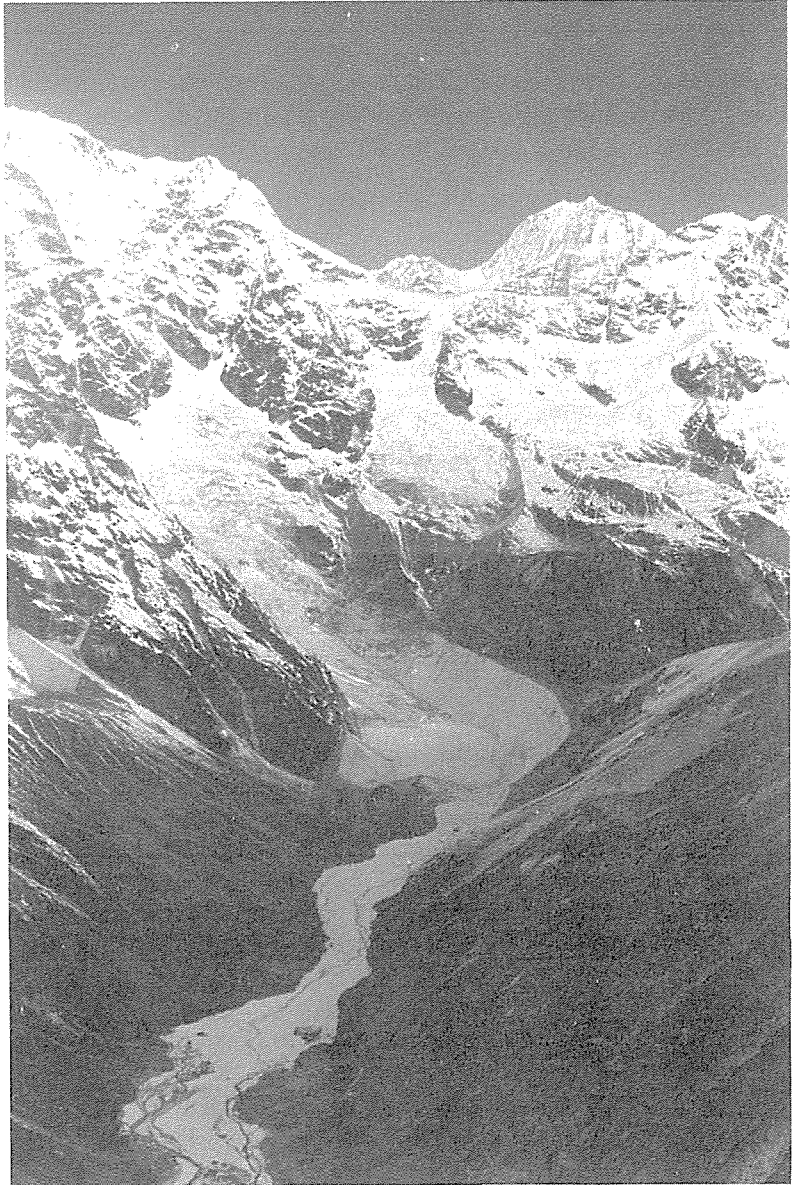
**Fig. 2** Trace of the Dig Tsho outburst on 4 August 1985.

9. 3 September 1977 Nare Drangka Glacier Lake (South slope of Mt. Ama Dablam). Ice-cored moraine collapse. Damaging min-hydro plant, roads, bridges, cultivation fields, etc.
10. 4 August 1985 Dig Tsho. Moraine collapse due to rock avalanche. Initial discharge of  $2000 \text{ m}^3 \text{ s}^{-1}$ . Destroying Namche hydropower plant completely, damaging roads, bridges, cultivation fields, livestock, houses, inhabitants, etc. Fig. 2 shows the trace of the outburst.

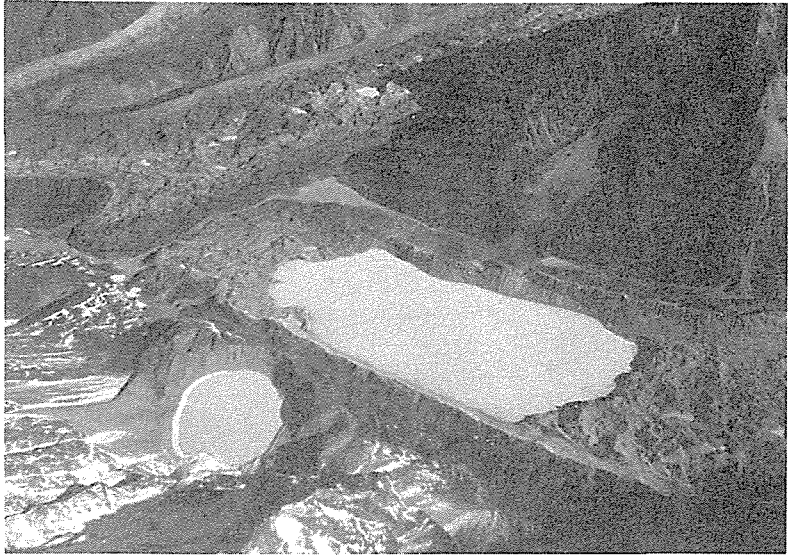
Fig. 4 Aerial photo of Imja Glacier Lake taken on 22 April 1991.

The aerial photo of Imja Glacier Lake, taken on 25 April 1991, is shown in Fig. 4. The lake developed on the end of the stagnant glacier tongue of Imja Glacier. The upper stream side of the lake touches on the cliff-shaped glacier end. The tongue area is covered by thick debris, which characterizes large glaciers in the Himalayas. The sides and lower stream areas of the lake are dammed by lateral and end moraines developed by past activities of Imja Glacier. The lateral moraines are quite high, assumed to be 70 m from the lake surface, though actual measurements were not made. The end moraine is relatively lower than the lateral moraines. The end moraine rises sharply up some 100 m above the river bed level of the Imja Khola. Lake water is being drained out to the Imja Khola through the small outlet on the end moraine, and the level of lake water is comparable to the lowest level of the end moraine.

The end moraine still includes glacier ice, that is, an ice-cored moraine. This is easily recognized by several characteristics: the existence of many outcrops of bare ice, numerous ponds formed by the meltwater of an ice body buried under the moraine, and traces of ponds previously formed and drained out. The lateral and end moraines are quite fresh and no vegetation cover is found on them. Furthermore, the moraine material is not cemented. The moraines may have been formed in the previous neo-glaciation period which occurred over the 15th to 19th centuries. During this period, Imja glacier surely advanced to the position of end moraine with the thickness up to the level of the top of the lateral moraines. The ice body under the end moraine is a fossil ice of Imja Glacier, which has remained without melting out due to the thick debris cover. This cover acts as a good heat insulator and results in a very low melting rate.

It is concluded that Imja Glacier Lake is one of the most dangerous glacier lakes in the Nepal Himalayas because of the huge amount of stored water, unstable ice-cored moraine and the relatively high density of population, including the many trekkers in the downstream area. This glacier lake has to be monitored constantly.

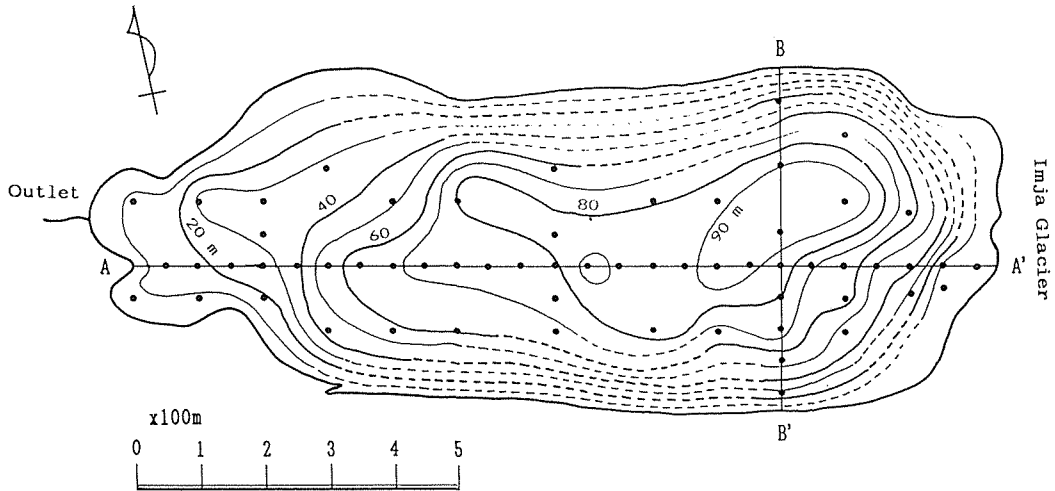
**Fig. 5** Depth contour map of Imja Glacier Lake. Solid circles show the measuring points of depth. The line A-A' and B-B' show the cross sections from Fig. 4.

The area of the lake is estimated at 595 000 m<sup>2</sup> (approximately 0.6 km<sup>2</sup>).

The deepest depth measured is 98.5 m. A map of the lake with depth contour lines is shown in Fig. 5. The longitudinal and the transversal cross section of the lake are shown in Fig. 6 (a) and (b), along the lines A-A' and B-B' on the map of Fig. 5, respectively.

The average depth of the lake is estimated at 47.0 m.

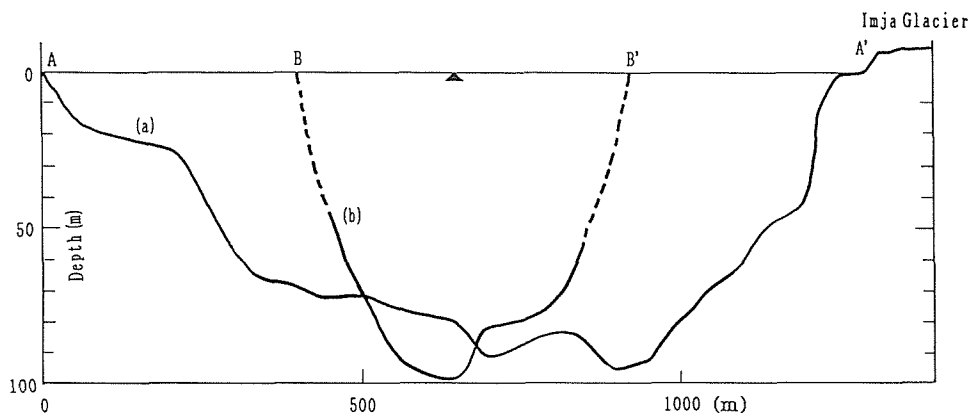
**Fig. 6** (a) Longitudinal and (b) transversal cross section of Imja Glacier Lake along the lines indicated A-A' and B-B' on the map of the lake in Fig. 3.

It is concluded that Imja Glacier Lake stores 27 965 000 m<sup>3</sup> (about  $28 \times 10^6$  m<sup>3</sup>) of water, which is derived from the lake area of 595 000 m<sup>2</sup> and average depth of 47.0 m.
